Navajo Abandoned Uranium Mine

Site Screen Report

Hoskie Henry AUM Site

August 2010

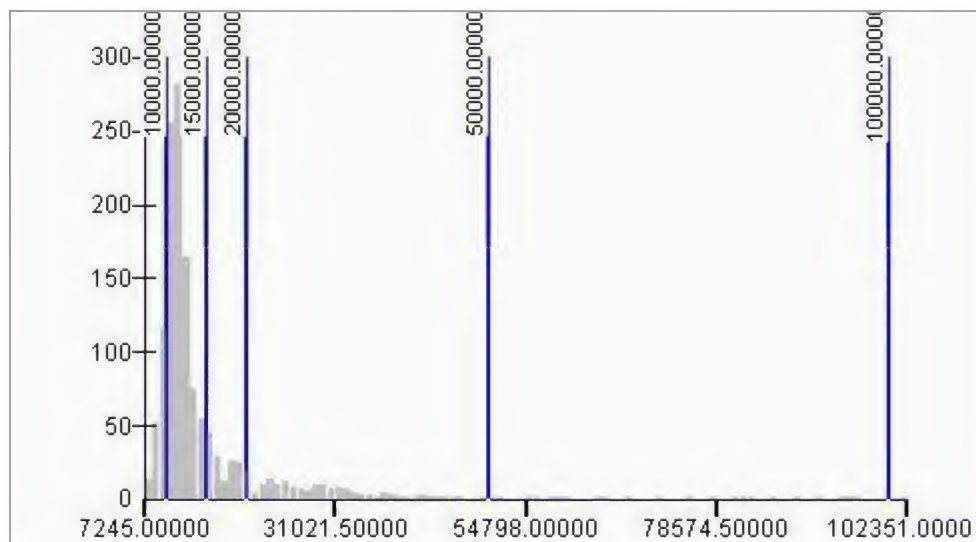
The following chart and statistics were generated by ESRI ArcGIS 9.3.1, and show the general distribution of the site gamma radiation measurements. The horizontal X axis represents the gamma radiation reading levels in cpm (lowest levels to the left). The vertical Y axis represents the frequency of each gamma radiation level.

Count:	1337
Minimum:	7245.00000
Maximum:	102351.00000
Sum:	20583177.00000
Mean:	15395.04637
Median:	11807.00000
Standard Deviation:	11147.42135

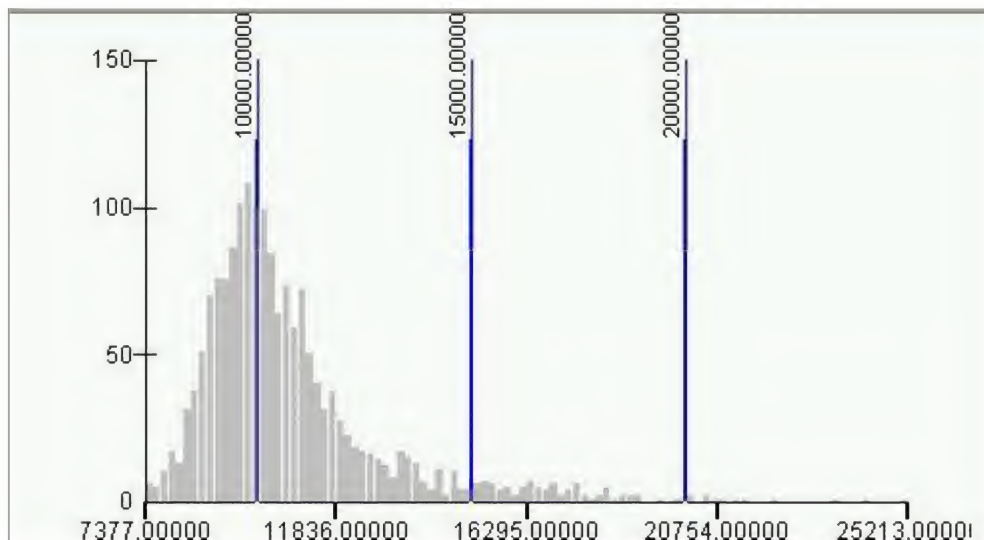
The following chart and statistics were generated by ESRI ArcGIS 9.3.1, and show the general distribution of the site gamma radiation measurements. The horizontal X axis represents the gamma radiation reading levels in cpm (lowest levels to the left). The vertical Y axis represents the frequency of each gamma radiation level.

Count:	1717
Minimum:	7377.00000
Maximum:	25213.00000
Sum:	18456890.00000
Mean:	10749.49913
Median:	10193.00000
Standard Deviation:	2195.20164

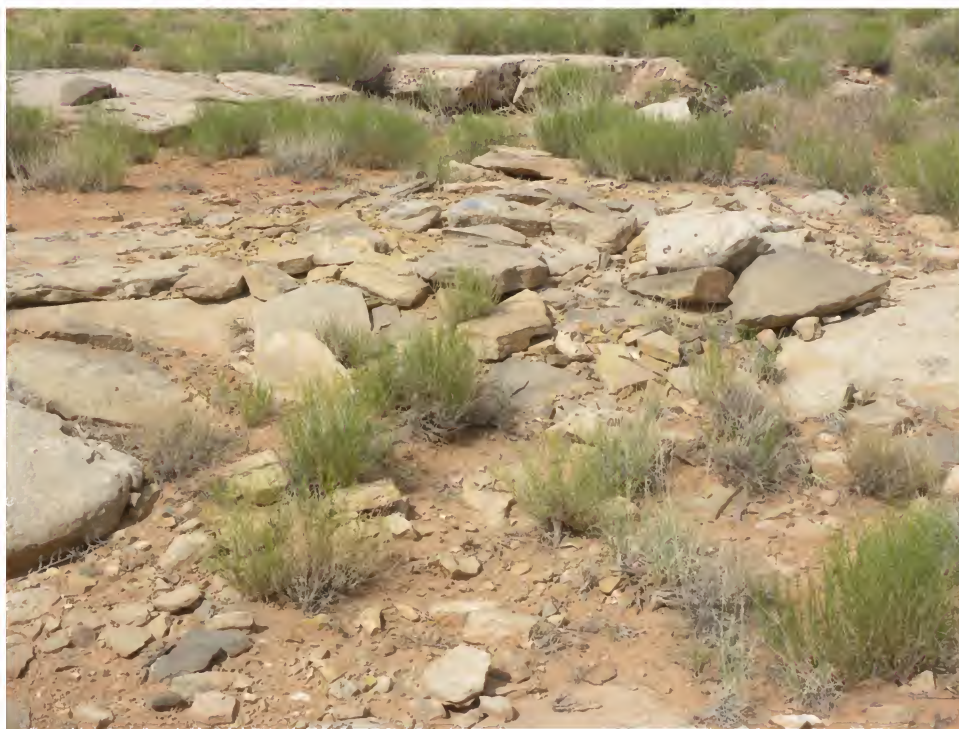
#635 – 8'x20'x1.5' waste rock pile

Photo 2. Henry Hoskie site #635, waste pile

Unreclaimed waste rock

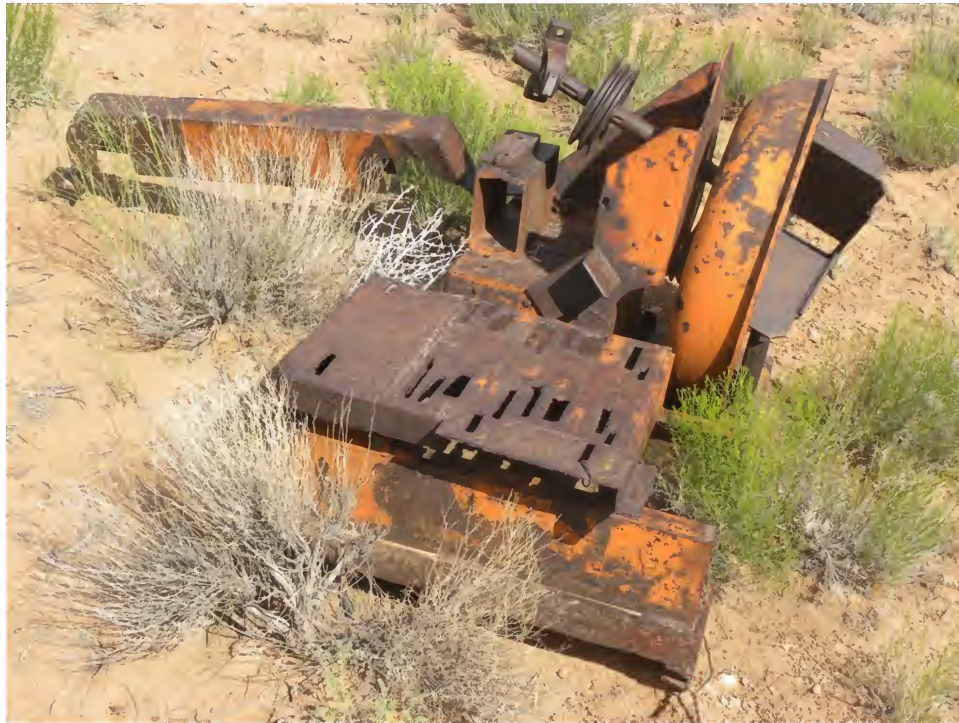
Various mining evidence, timber, drill bits, etc., throughout site

Photo 3. Henry Hoskie site #635, mining debris

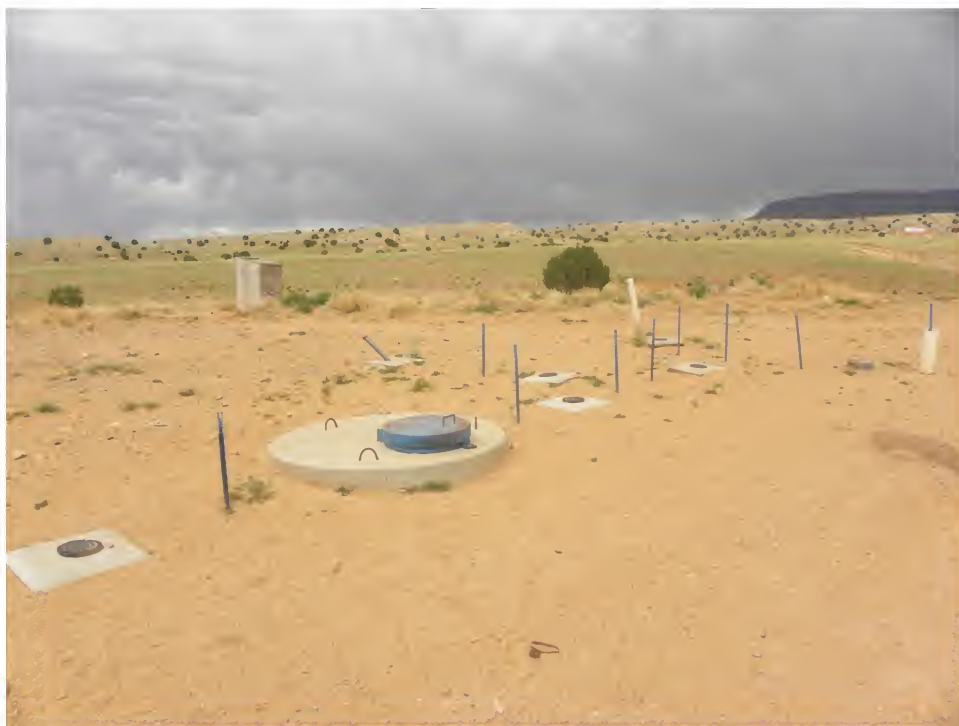
0 to 0.25 miles: Well at Clark house, 0.1 mi N of site #636 and 0.2 mi NW of site #635

Photo 7. Clark housing compound well

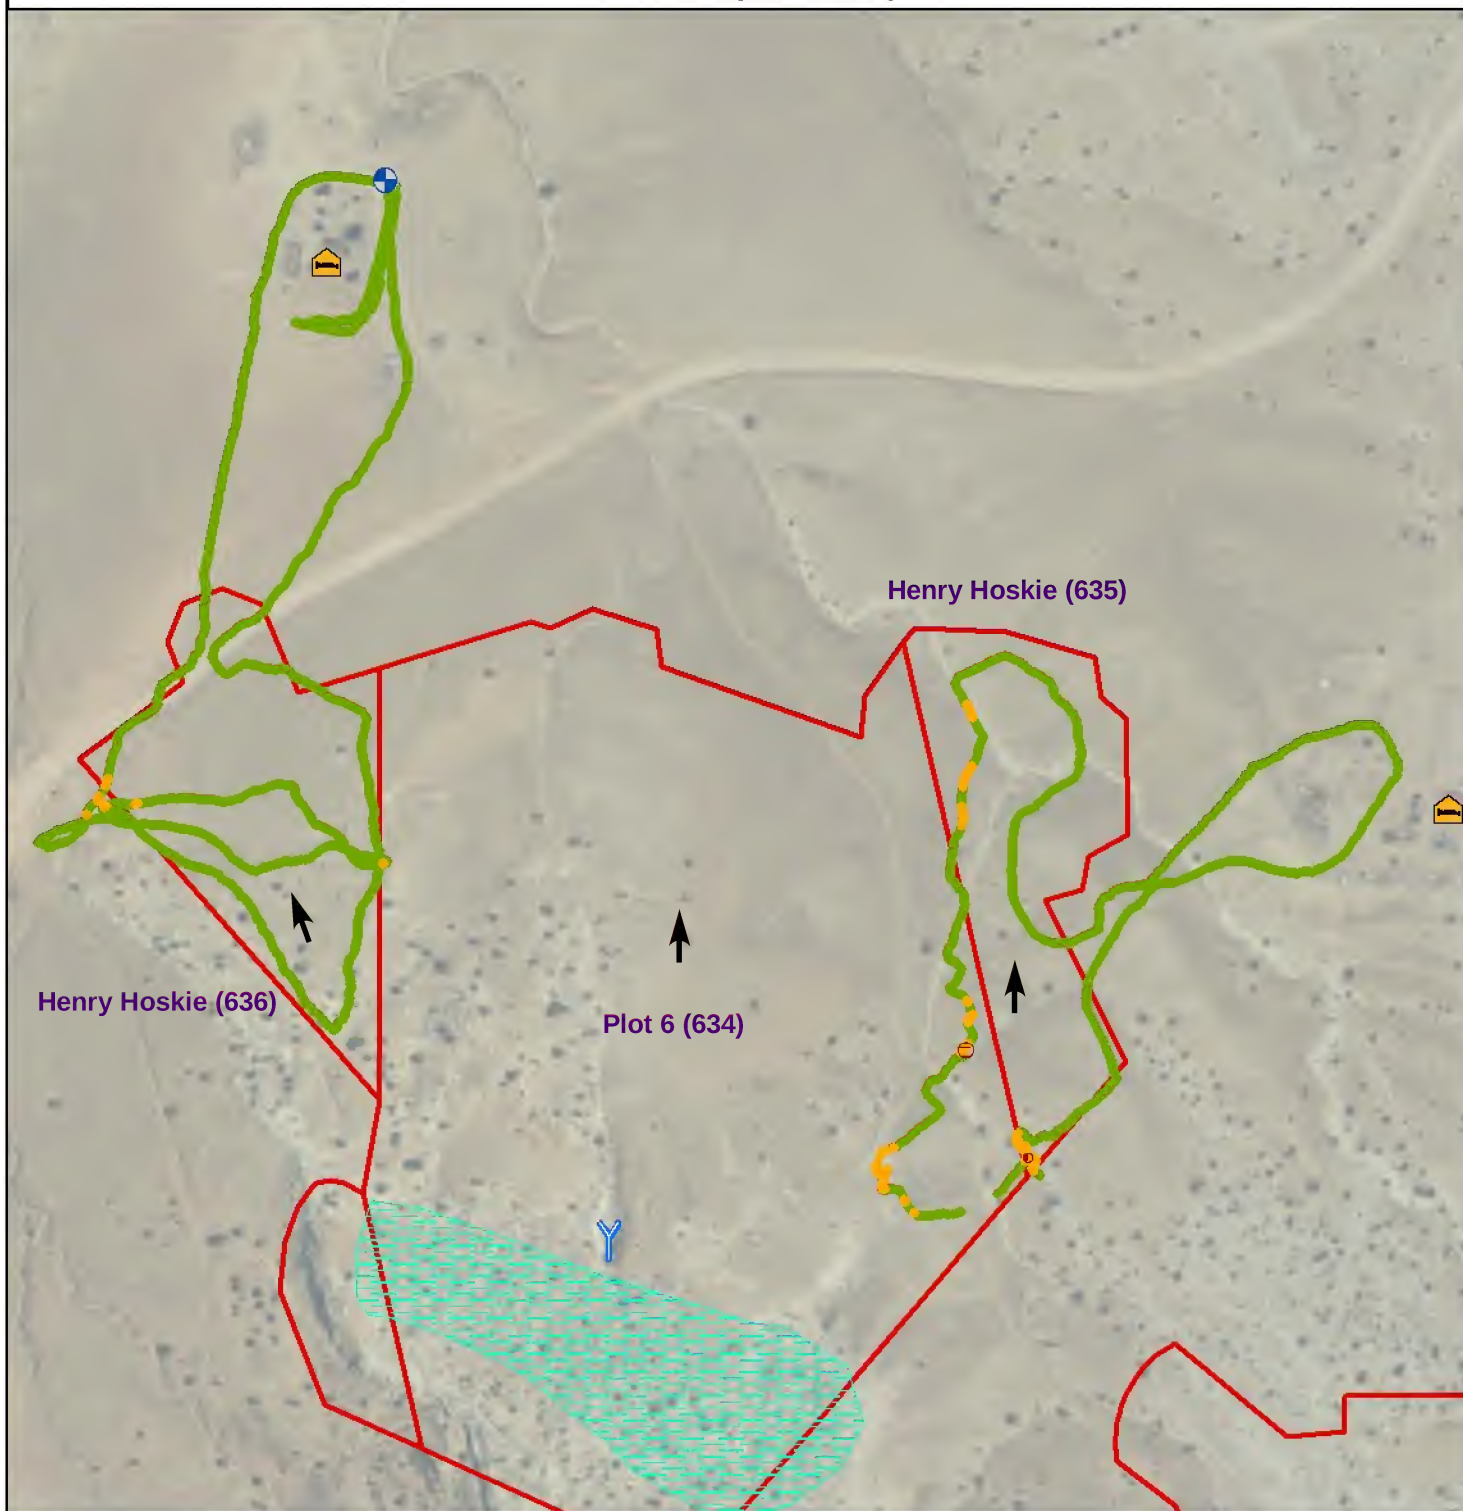
A total of 1,337 gamma radiation measurements were collected from the mine site, ranging from 7,245 cpm to 102,351 cpm. Measurements collected in the vicinity of the waste debris were found at levels up to approximately 100,000 cpm, and the drainage at levels up to approximately 30,000 cpm. The measurements are represented in Figures 1 and 2.

**Figure 1 - Gamma Radiation Measurements, Above Two Times Background
Henry Hoskie (635, 636)
Teec Nos Pos Chapter, Navajo Nation**

Gamma survey conducted 06/2010
Measured as counts per minute (cpm)

Average background = 9,749 cpm

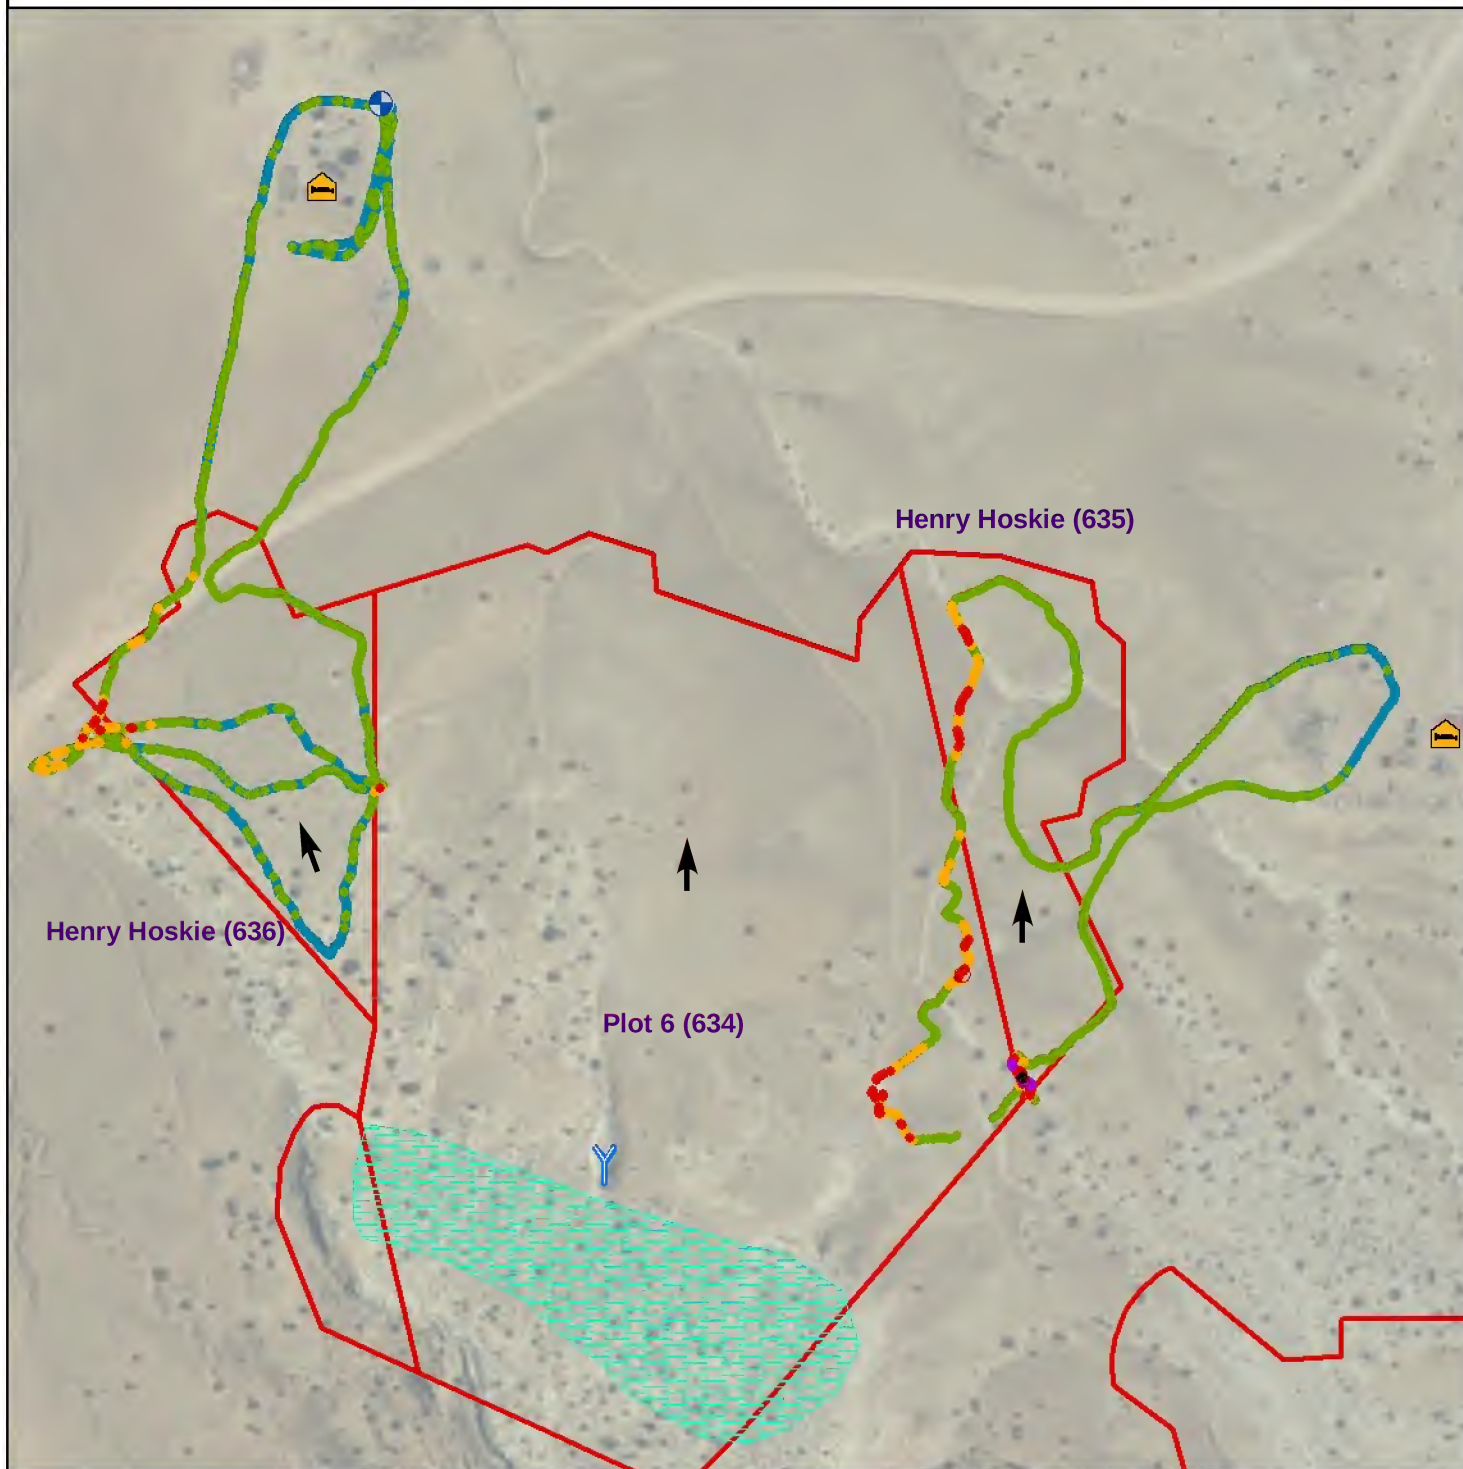
A total of 1,717 gamma radiation measurements were collected from the mine site, ranging from 7,377 cpm to 25,213 cpm. The measurements are represented in Figures 1 and 2.

Figure 2 - Gamma Radiation Measurements
Henry Hoskie (635, 636)
Teec Nos Pos Chapter, Navajo Nation

Gamma survey conducted 06/2010
 Measured as counts per minute (cpm)
 Average background 9,749 cpm
